# RQL Sector Rig Testing of SiC/SiC Combustor Liners

Michael J. Verrilli and Lisa C. Martin  
Glenn Research Center, Cleveland, Ohio

Combustor liners, manufactured from silicon carbide fiber-reinforced silicon carbide, (SiC/SiC), were tested for 260 hrs using a simulated gas turbine engine cycle. This report documents the results of the last 56 hours of testing. Damage occurred in one of the six different components that make up the combustor liner set, the rich zone liner. Cracks in the rich zone liner initiated at the leading edge due to stresses resulting from the component attachment configuration. Thin film thermocouples and fiber optic pyrometers were used to measure the rich zone liner's temperature and these results are reported.

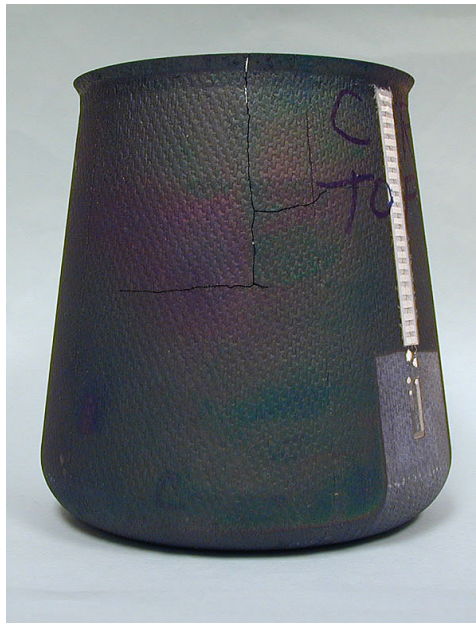
Cracking was found after the first test run of 7.5 hours in the CR side RZL (555-07-009). The crack initiated at the leading edge, grew about 2-3/4 in. along the flow direction, and bifurcated, turning 90° (i.e., in a circumferential direction). Another 90° crack branch existed about 1-3/4 in. from the leading edge (Figure 7). Propagation of these circumferential cracks was observed after the second test run of 8 hours.

Figure 7 – Post test picture of cracking in rich zone liner 555-07-009.  
Note the thin film thermocouple and wire leads.

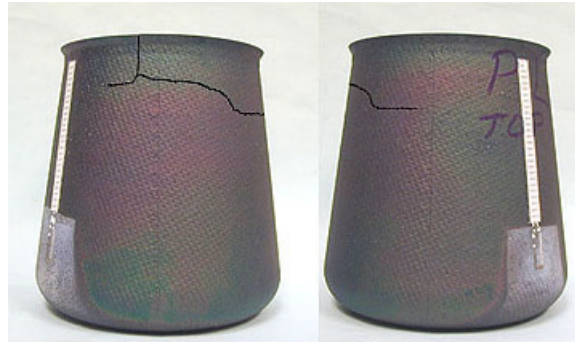
After the second test run, cracking that initiated at the leading edge was detected in the PL side RZL (555-07-010) as well. The crack was about 3/4 in. long, in a direction parallel to the flow direction, and it bifurcated. The circumferential portion of this crack spanned over 90° of the RZLs circumference, Figure 8. Relative displacement of the crack faces perpendicular to the flow direction was imaged with the boroscope. To avoid further damage and potential RZL failure during subsequent testing, both RZLs were removed and replaced with new ones. The replacement PL-side RZL (253-07-210) developed a leading edge crack after the third test run. Boroscope inspection after the fourth run imaged a second leading edge crack, 180° apart from the initial crack. The second crack initiated on a fiber cloth splice that was visible on the inner diameter of the RZL (Figure 9). Continued propagation of these two cracks was

Figure 8 – Post test pictures of rich zone liner 555-07-110, a) initiation site of crack at leading edge and branching in a circumferential direction, b) rotated view the can, showing the location of the crack tip.

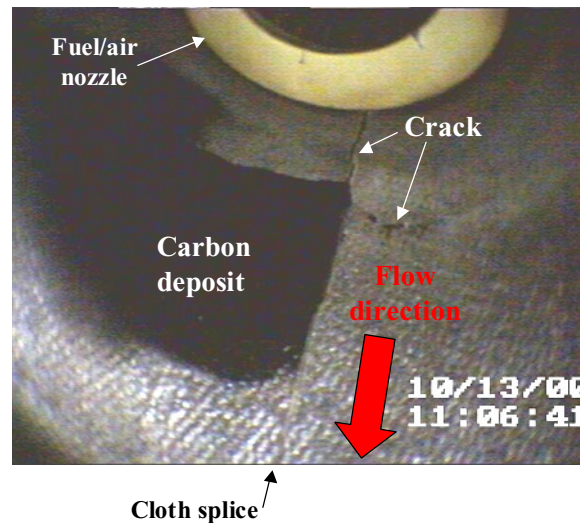
Figure 9 – Boroscope image of the ID of rich zone liner 253-07-210 showing crack initiation and growth from the leading edge on a ply splice.

observed after the fifth run. Both cracks were about 2 in. long, with a 90° branch. These branches were along circumferential directions. Also, a leading edge crack was now visible in the replacement CR-side RZL.

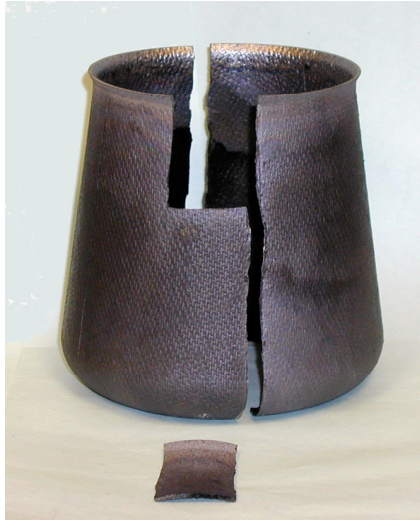
Inspection after the sixth run revealed that failure of the PL-side RZL occurred. An independent 2 in. long by 1-3/4 in. wide section was created when a new leading edge crack linked with an existing crack that had turned in a circumferential direction (Figure 10). Testing was suspended due to this damage. Note that the extensive cracking caused the RZL to split into two halves upon removal from the sector rig.

Figure 10 – Post-test view of PL-side RZL (253-07-210) showing damage that occurred after 40.5 hours of testing.

ranked lower than the six tested in 1999. In particular, the last PL-side RZL (253-07-210) that failed (Figure 10) had the lowest rank of the ten.

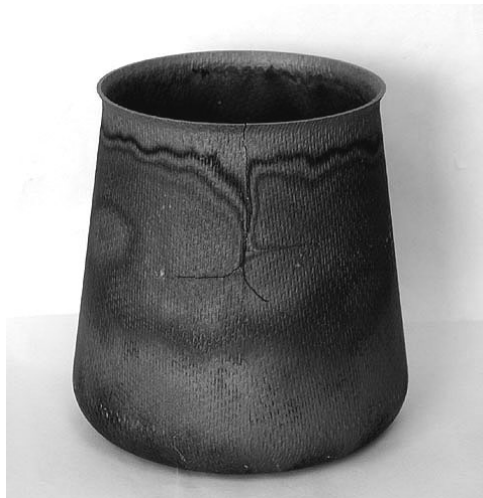
Figure 11 – Post-test image of CR-side RZL (555-07-005). Note the oxidation and crack originating from the leading edge.

A post-test image of the replacement CR-side RZL is shown in Figure 11. Similar to the PL-side RZL, a 2 in. leading edge crack that turned 90° exists.

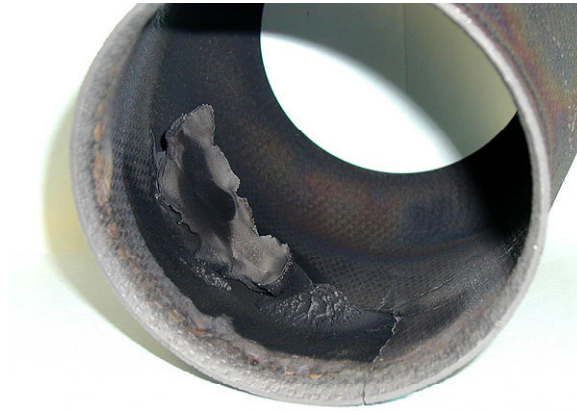
Carbon deposits are present in every tested RZL (Figure 12). Boroscope inspections revealed that carbon deposits form during the initial test exposure and grow with continued testing. Once formed, these carbon deposits typically remained on the ID of a RZL unless they grow significantly in a direction normal to the flow. In these cases, the forces of the flowing gas stream fracture the carbon deposits. Evidence indicating the results of carbon deposit growth and fracture was the large quantities of carbon nuggets that accumulated in the cooling water used downstream of the combustor.

Figure 12 – Carbon deposits and cracking in CR-side RZL (555-07-005) after 40.5 hours of testing.

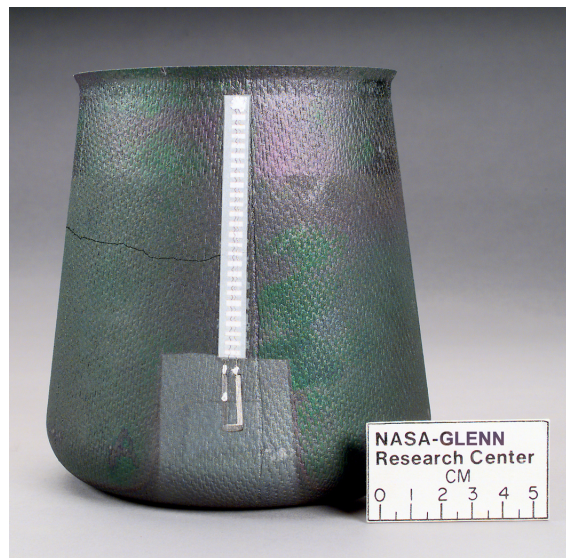
Figure 16 – Condition of a thin film thermocouple on a rich zone liner after combustion exposure.

Post-test analysis of the thermocouples revealed that the thin film thermocouples were intact and electrically continuous. There appeared to be very little physical damage to the films (Figure 16). However, the welds that held the platinum-13% rhodium wires to the films failed. The aluminum oxide insulation films were intact for all but one of the thermocouples. The fourth thermocouple had some flaking in the aluminum oxide film, resulting in lowered

The post-test analysis of the sensors indicated that the thin films and leadwires survived the test conditions, however the welds between the wires and thin films did not. The wires did not maintain full and intimate contact with the films. This may have contributed to the erratic data that occurred during the temperature increase after the combustor was lit. In particular, the platinum-13% rhodium wires failed to remain in contact with the films. This may have been due to oxidation of the rhodium in both the wire and the exposed film. During sensor fabrication, the film was not completely covered by the protective aluminum oxide overcoat to allow attachment of the leadwires. The degradation in the output signals during high temperature exposure may have been caused by a change in the composition of the exposed films and fine wires. Analysis of the thermocouple data indicates that the connections between the wires and films failed prior to the initiation of the actual sector testing, during the initial period during which the hardware was exposed to high temperature, high flow air. The

thin film thermocouples were installed in a region of the rig that was exposed to the cooling air flow. It is also possible that the force of this air flow damaged the welds between the wires and the thin films.

While the thin films proved to be physically durable during this testing, the failure of the wires and the degradation in the signal output demonstrates that the thin film-to-leadwire connections need to be improved for durability and the thin films need to be more fully protected from the harsh test environment.
